# **CRITICAL AREAS REPORT AND MITIGATION PLAN**

## **MILANO ISSAQUAH APARTMENTS**

### **ISSAQUAH, WASHINGTON**

18 September 2020  
(*Revised 15 September 2022*)

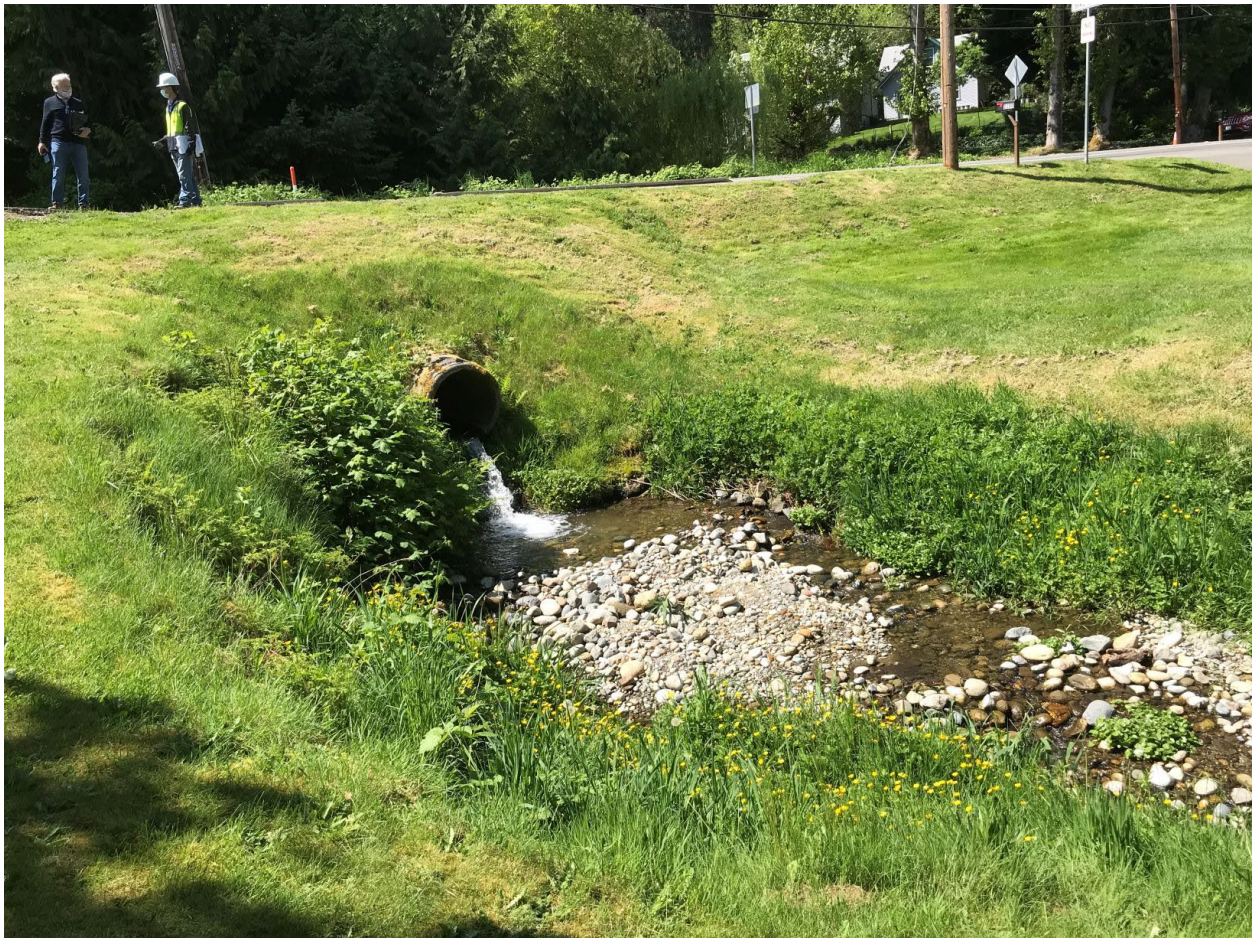
**Photo 1.** Perched culvert at Newport Way NW, Oriented Southwest. property boundary.

Schneider Creek is a small fish-bearing stream located partially on the southeastern portion of the property and offsite to the east (**Sheet W1.0 of Appendix A**). The drainage basin of Schneider Creek is approximately 155 acres in size and is located in the hills southwest of the City limits of Issaquah. The stream originates in a portion of unincorporated King County between SE 60<sup>th</sup> Street and SE 62<sup>nd</sup> Place. It flows through a wooded ravine for approximately 3,000 feet to a 2.5-foot-diameter round concrete culvert under Newport Way NW, which is scheduled to be replaced with a fish-passable culvert by the City of Issaquah. The outfall of this culvert is perched onsite by approximately two feet and represents a barrier to fish migration (**Photo 1**). From Newport Way NW, the creek flows in a northerly direction to the north

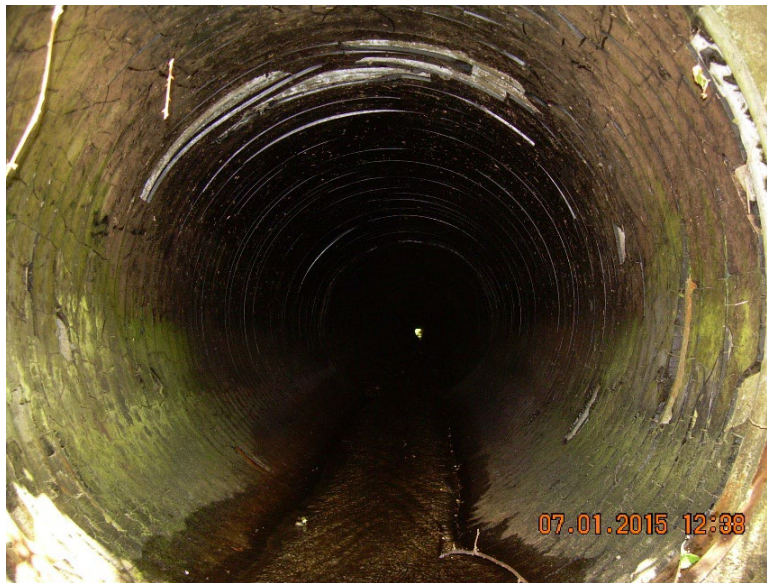
**Photo 2.** Schneider Creek in I-90 culvert, Oriented South.

It exits the property near the northeast corner of the Site. Schneider Creek then flows in a northwesterly direction for approximately 430 feet to a 3.5-foot-diameter corrugated metal culvert under I-90 and West Lake Sammamish Parkway (**Photo 2**). After passing under I-90 and

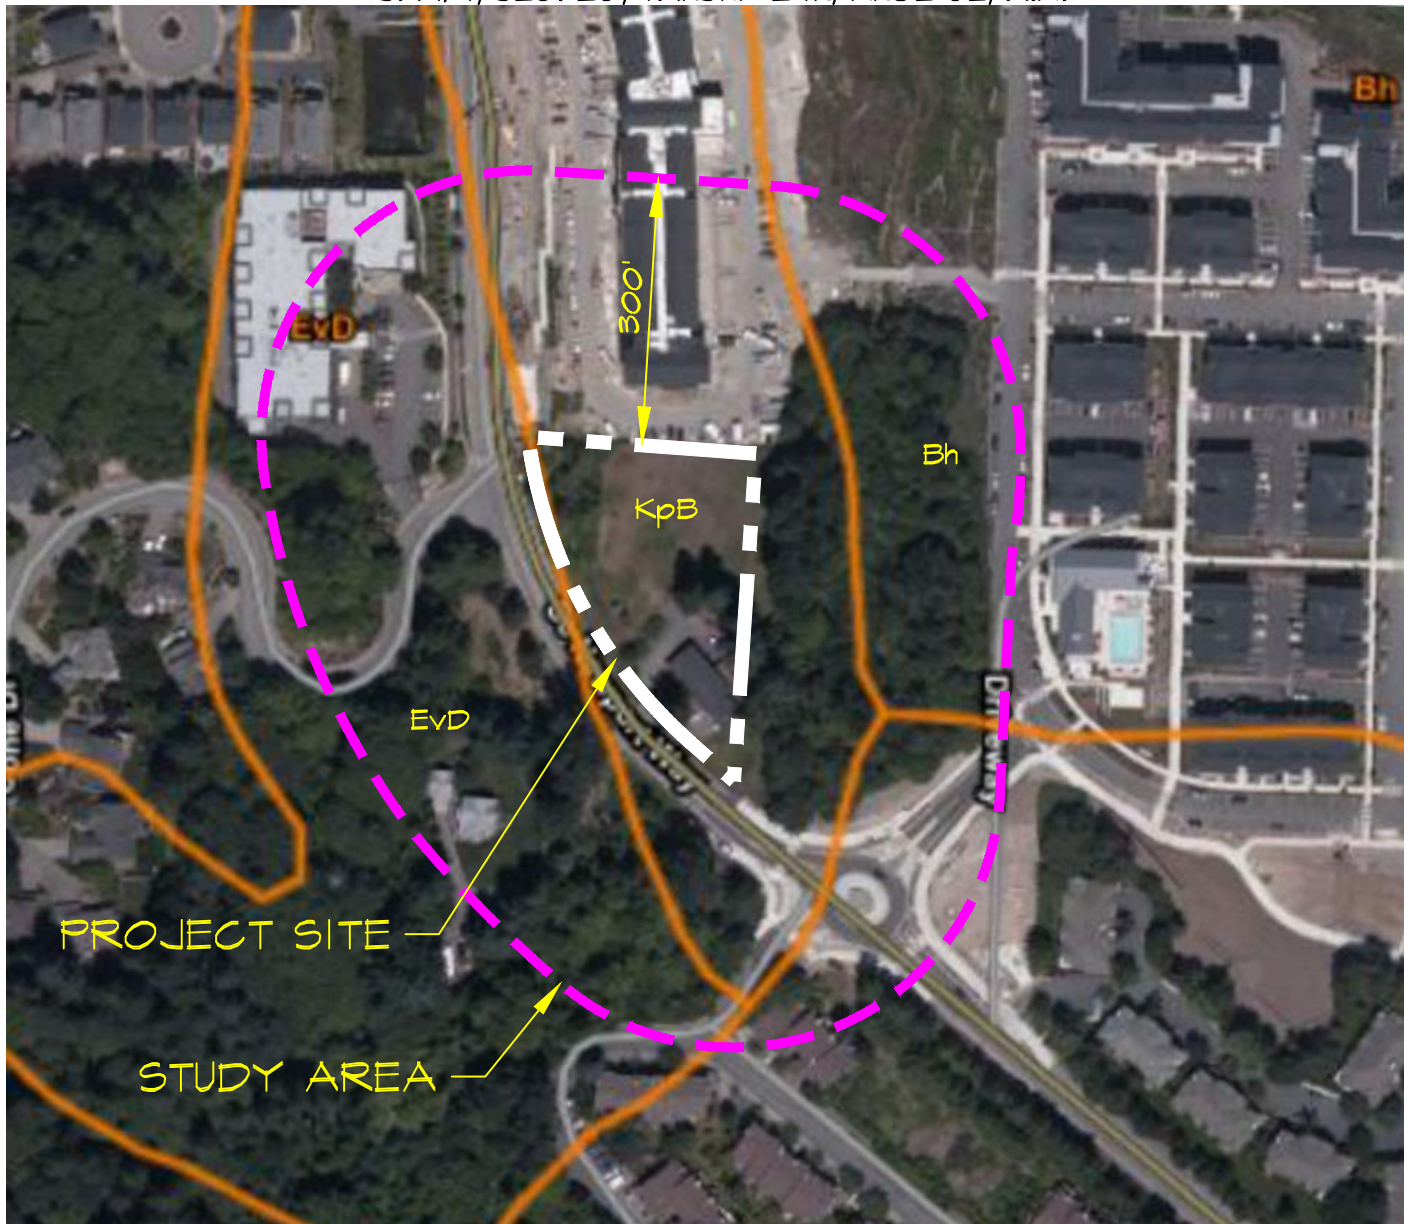
3

TYPE	DESCRIPTION, SLOPES
EVD	EVERETT VERY GRAVELLY SANDY LOAM, 15 TO 30 PERCENT SLOPES
KpB	KITSAP SILT LOAM, 2 TO 8 PERCENT SLOPES
Bh	BELLINGHAM SILT LOAM

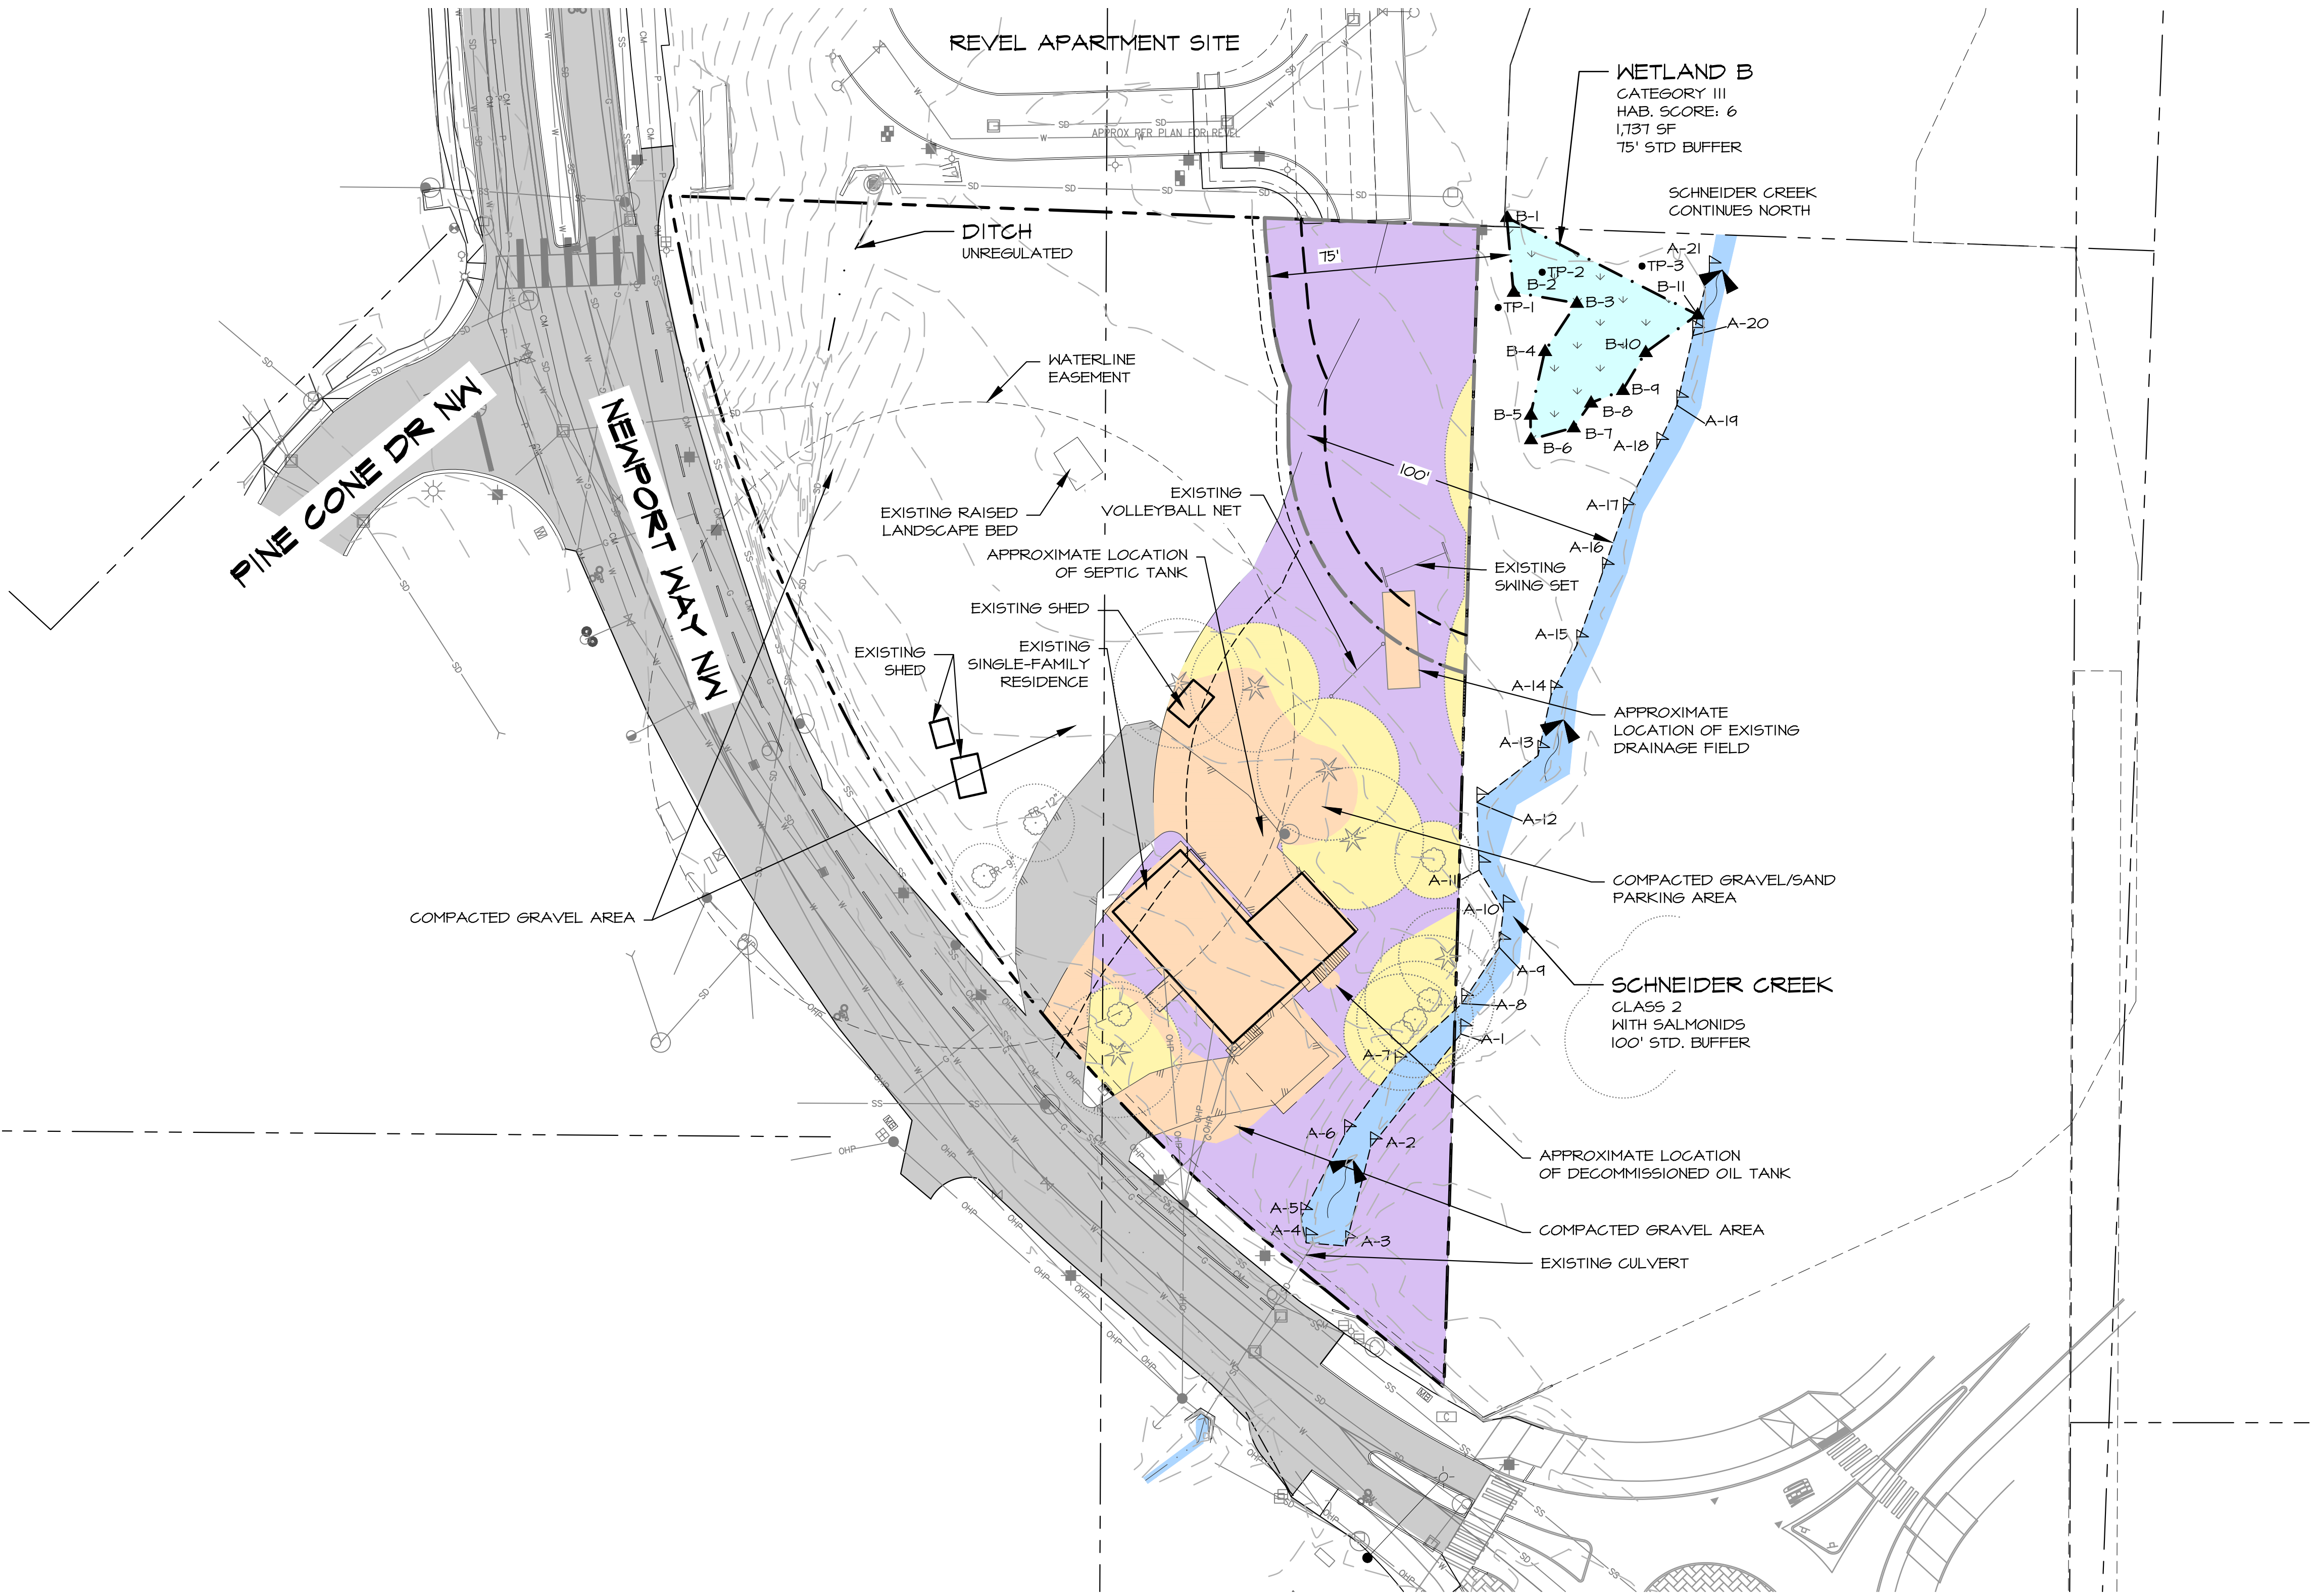
Sheet # W1.0

EXISTING CONDITIONS PLAN

The Site is currently accessed from a paved driveway off Newport Way NW that provides access to the existing residence located on the Site (**Sheet W1.0 of Appendix A**). Several storage sheds are also found near the existing residence, and the remainder of the Site is composed of maintained lawn. Schneider Creek is partially located on the southeastern portion of the Site.

There is approximately 11,905 sf of impervious surface found on the property. The Milano Issaquah Apartments development will remove the approximately 7,929 sf found within the standard Schneider Creek buffer (**Sheet W1.0 of Appendix A**). These impervious surfaces include a septic tank drain field, abandoned fuel tanks, and the existing residence and its associated drive aisles which are located as close as 20 feet from Schneider Creek. Impervious surfaces removed will exceed the required amount by 803 sf.

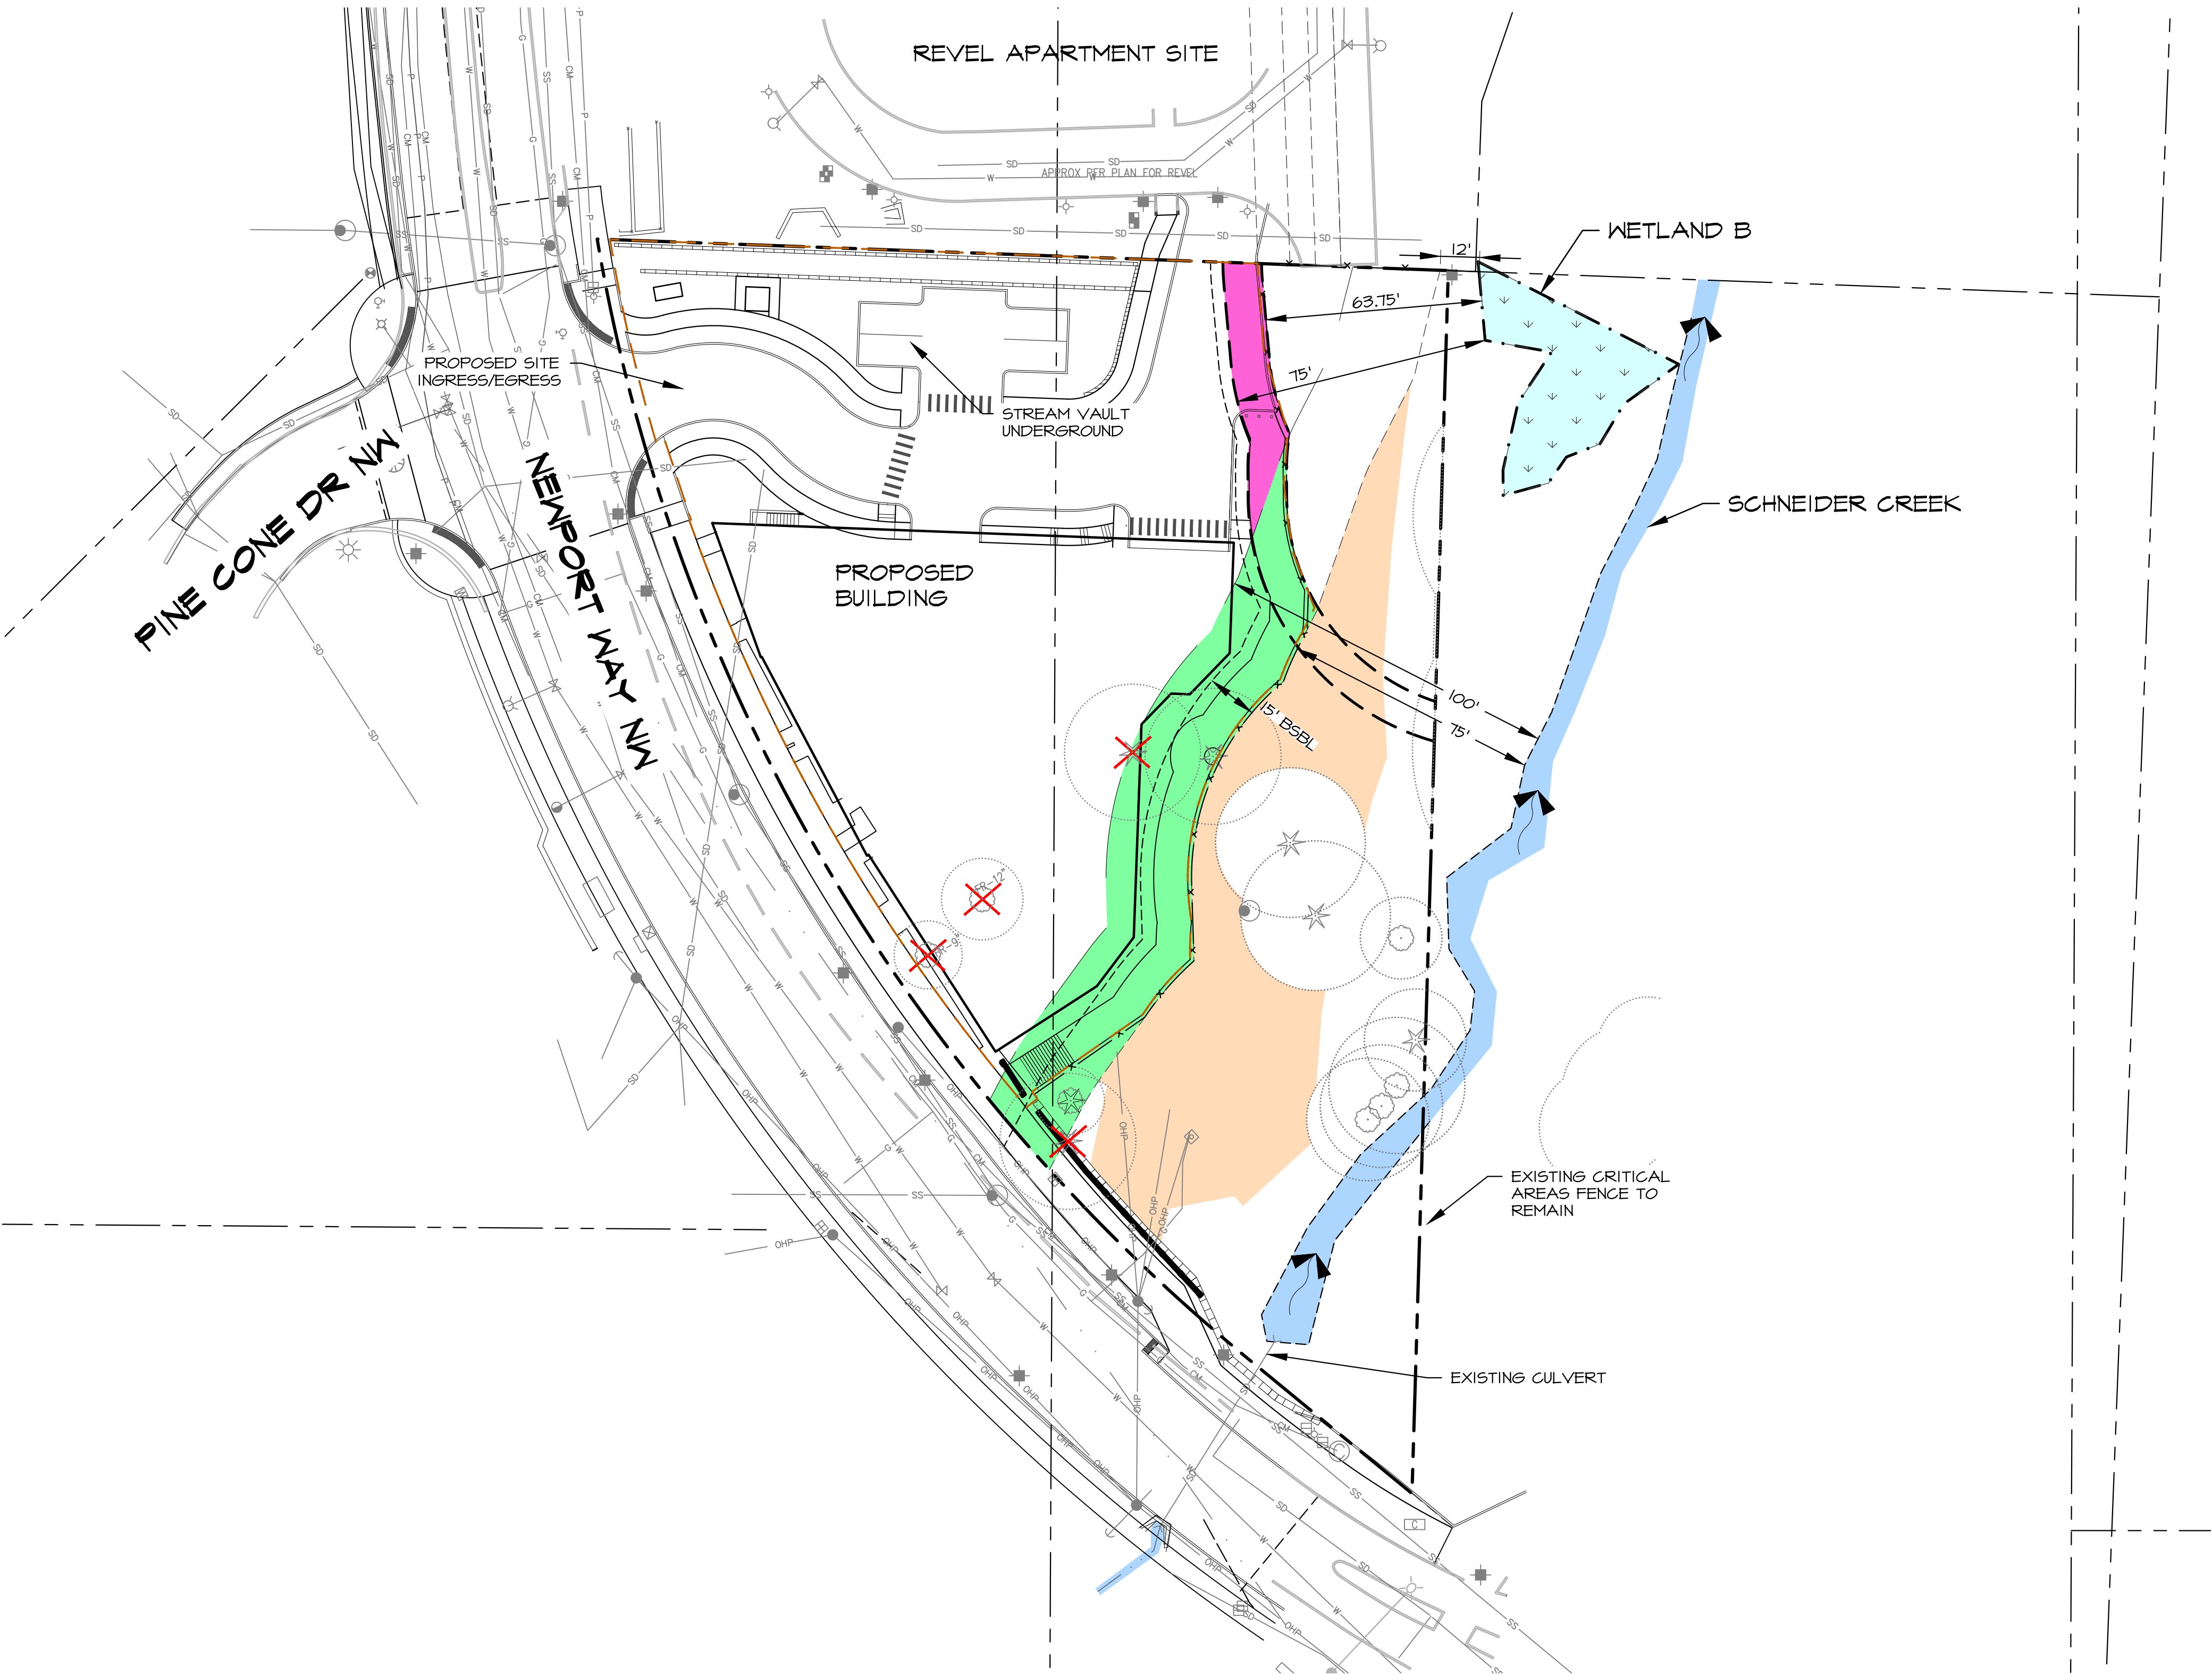
Sheet # W2.0

PROPOSED SITE PLAN, IMPACTS & MITIGATION OVERVIEW PLAN

All temporarily disturbed buffer areas on the project Site shall be restored through the decompaction of soils, planting of native trees and shrubs to prevent erosion or re-establishment of invasive species, and provide increased species structure and diversity over existing conditions (**Sheets W2.0 and W2.1 of Appendix A**). In addition, discharge of clean roof runoff

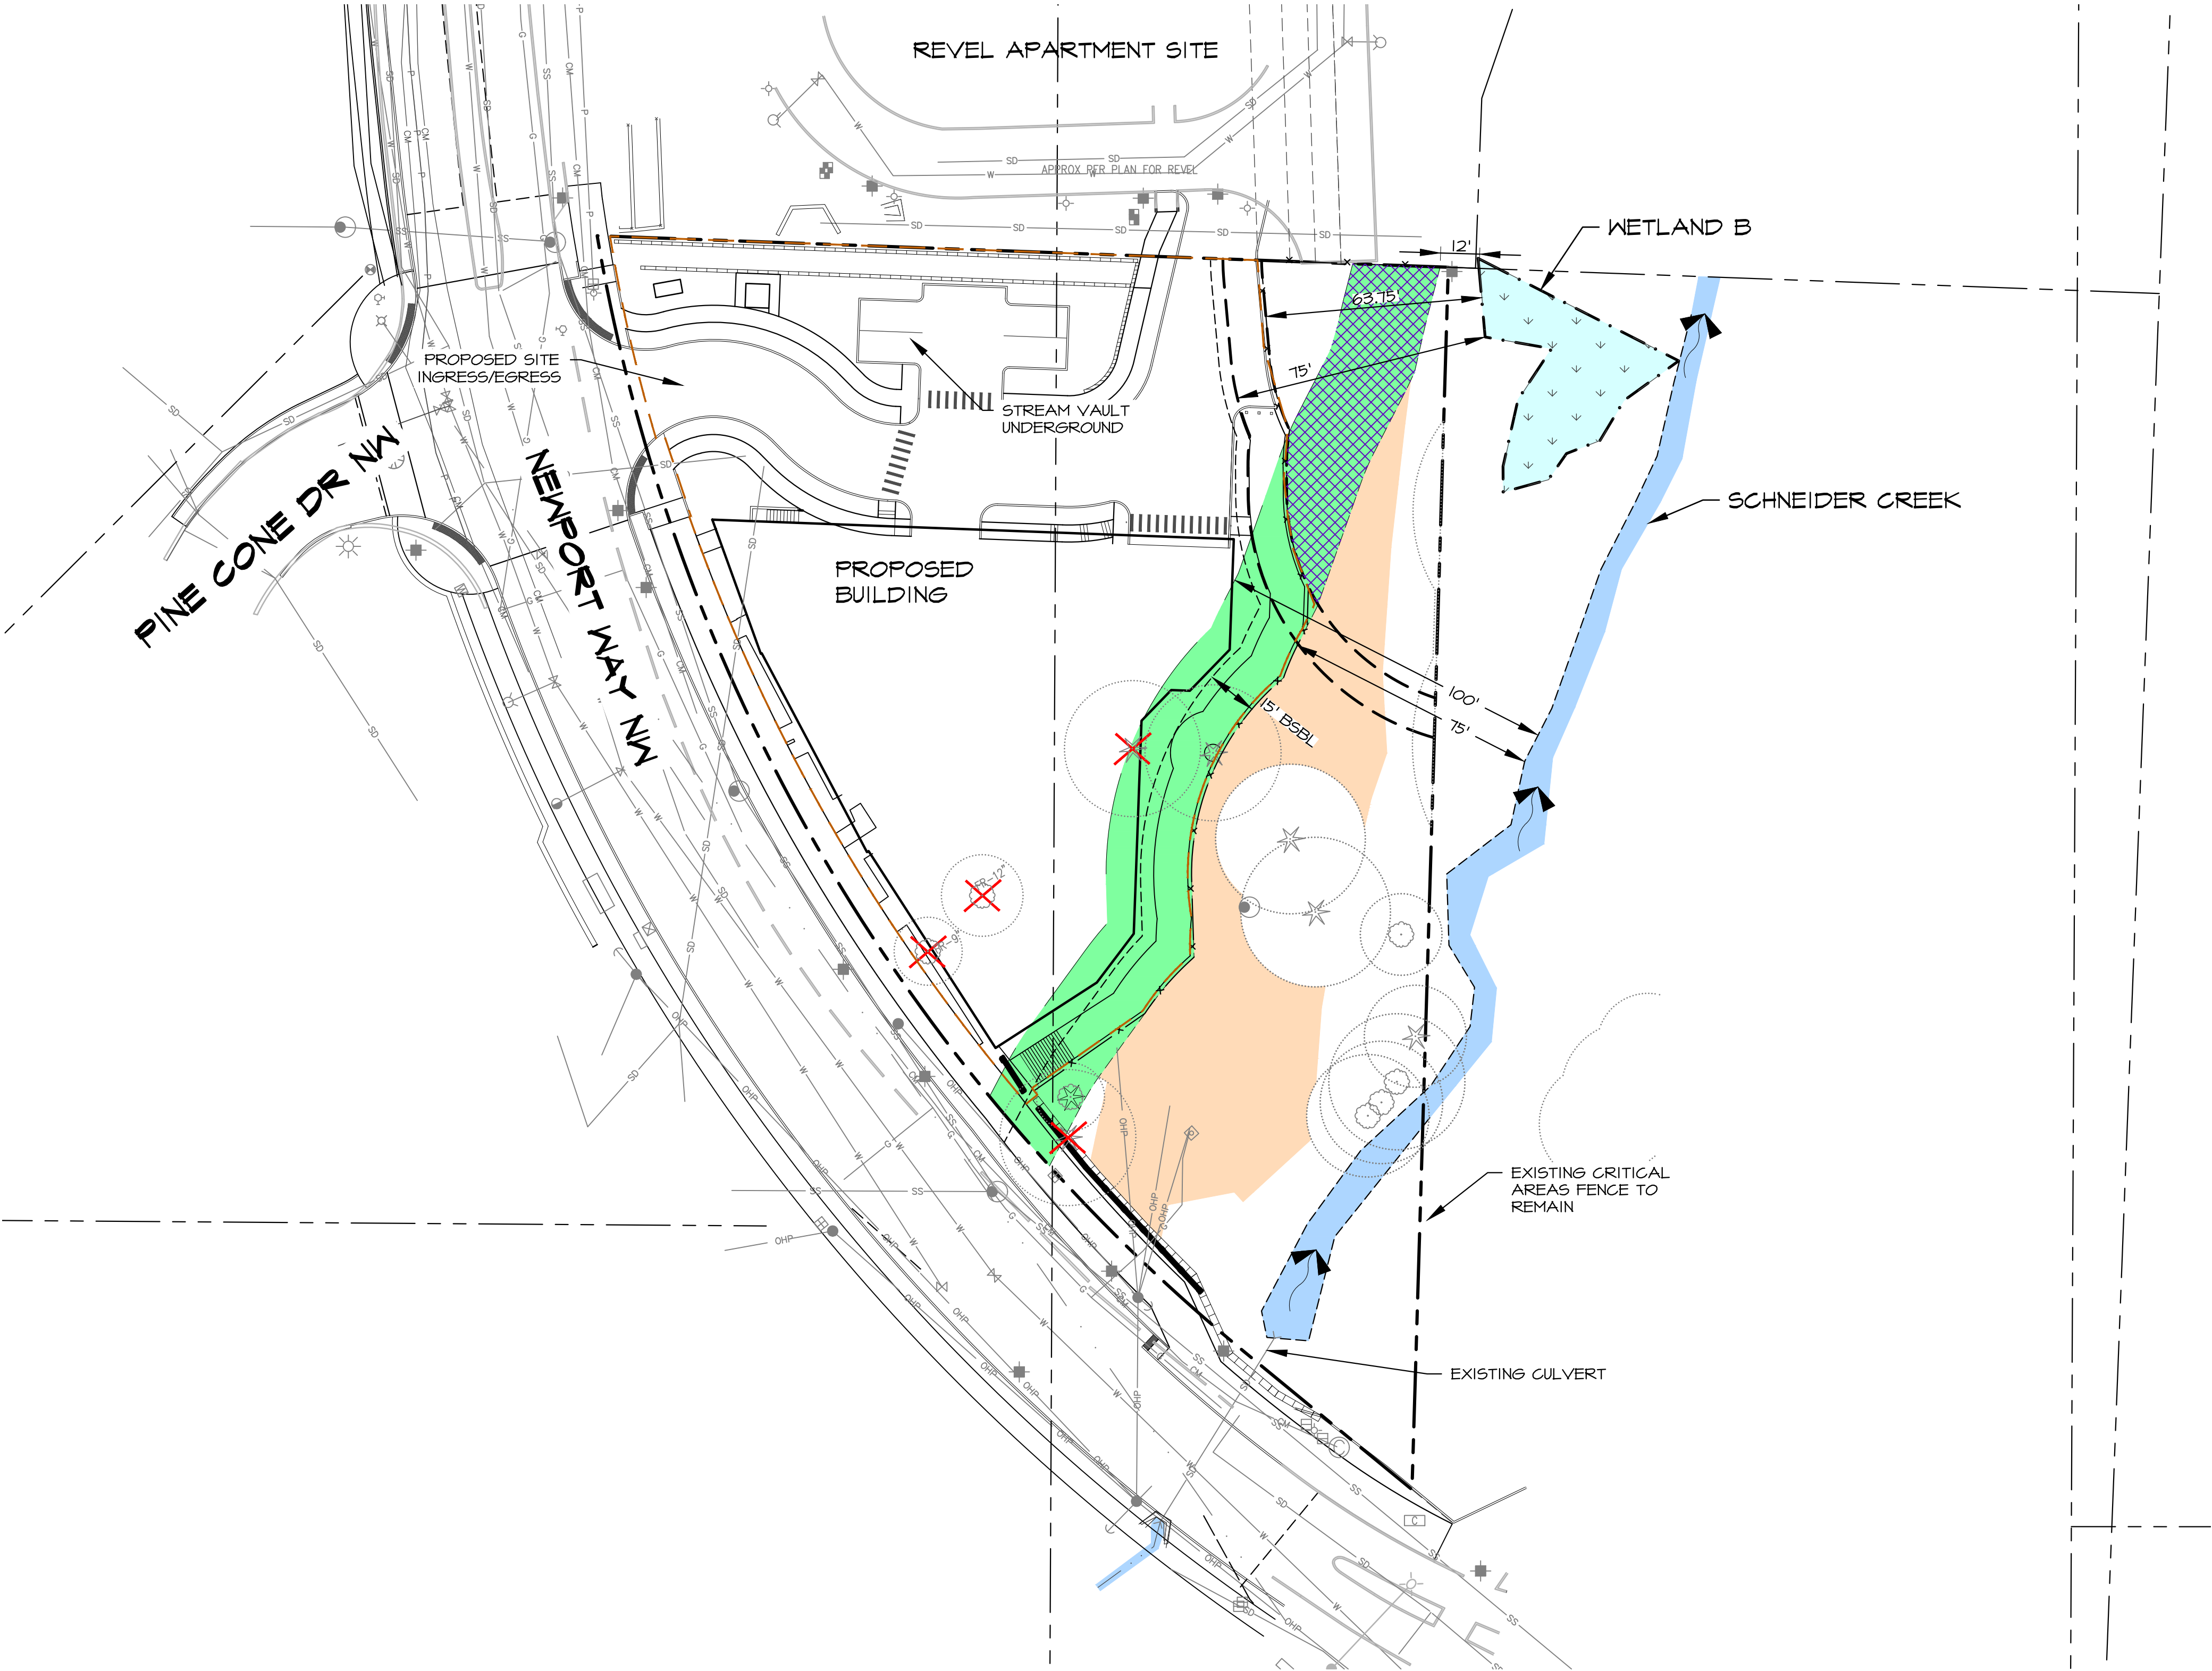
Sheet # W2.0a

CRITICAL AREAS MITIGATION PLAN  
PROPOSED STREAM IMPACTS OVERVIEW PLAN  
MILANO ISSAGUAH APARTMENTS PROJECT  
ISSAGUAH, WASHINGTON

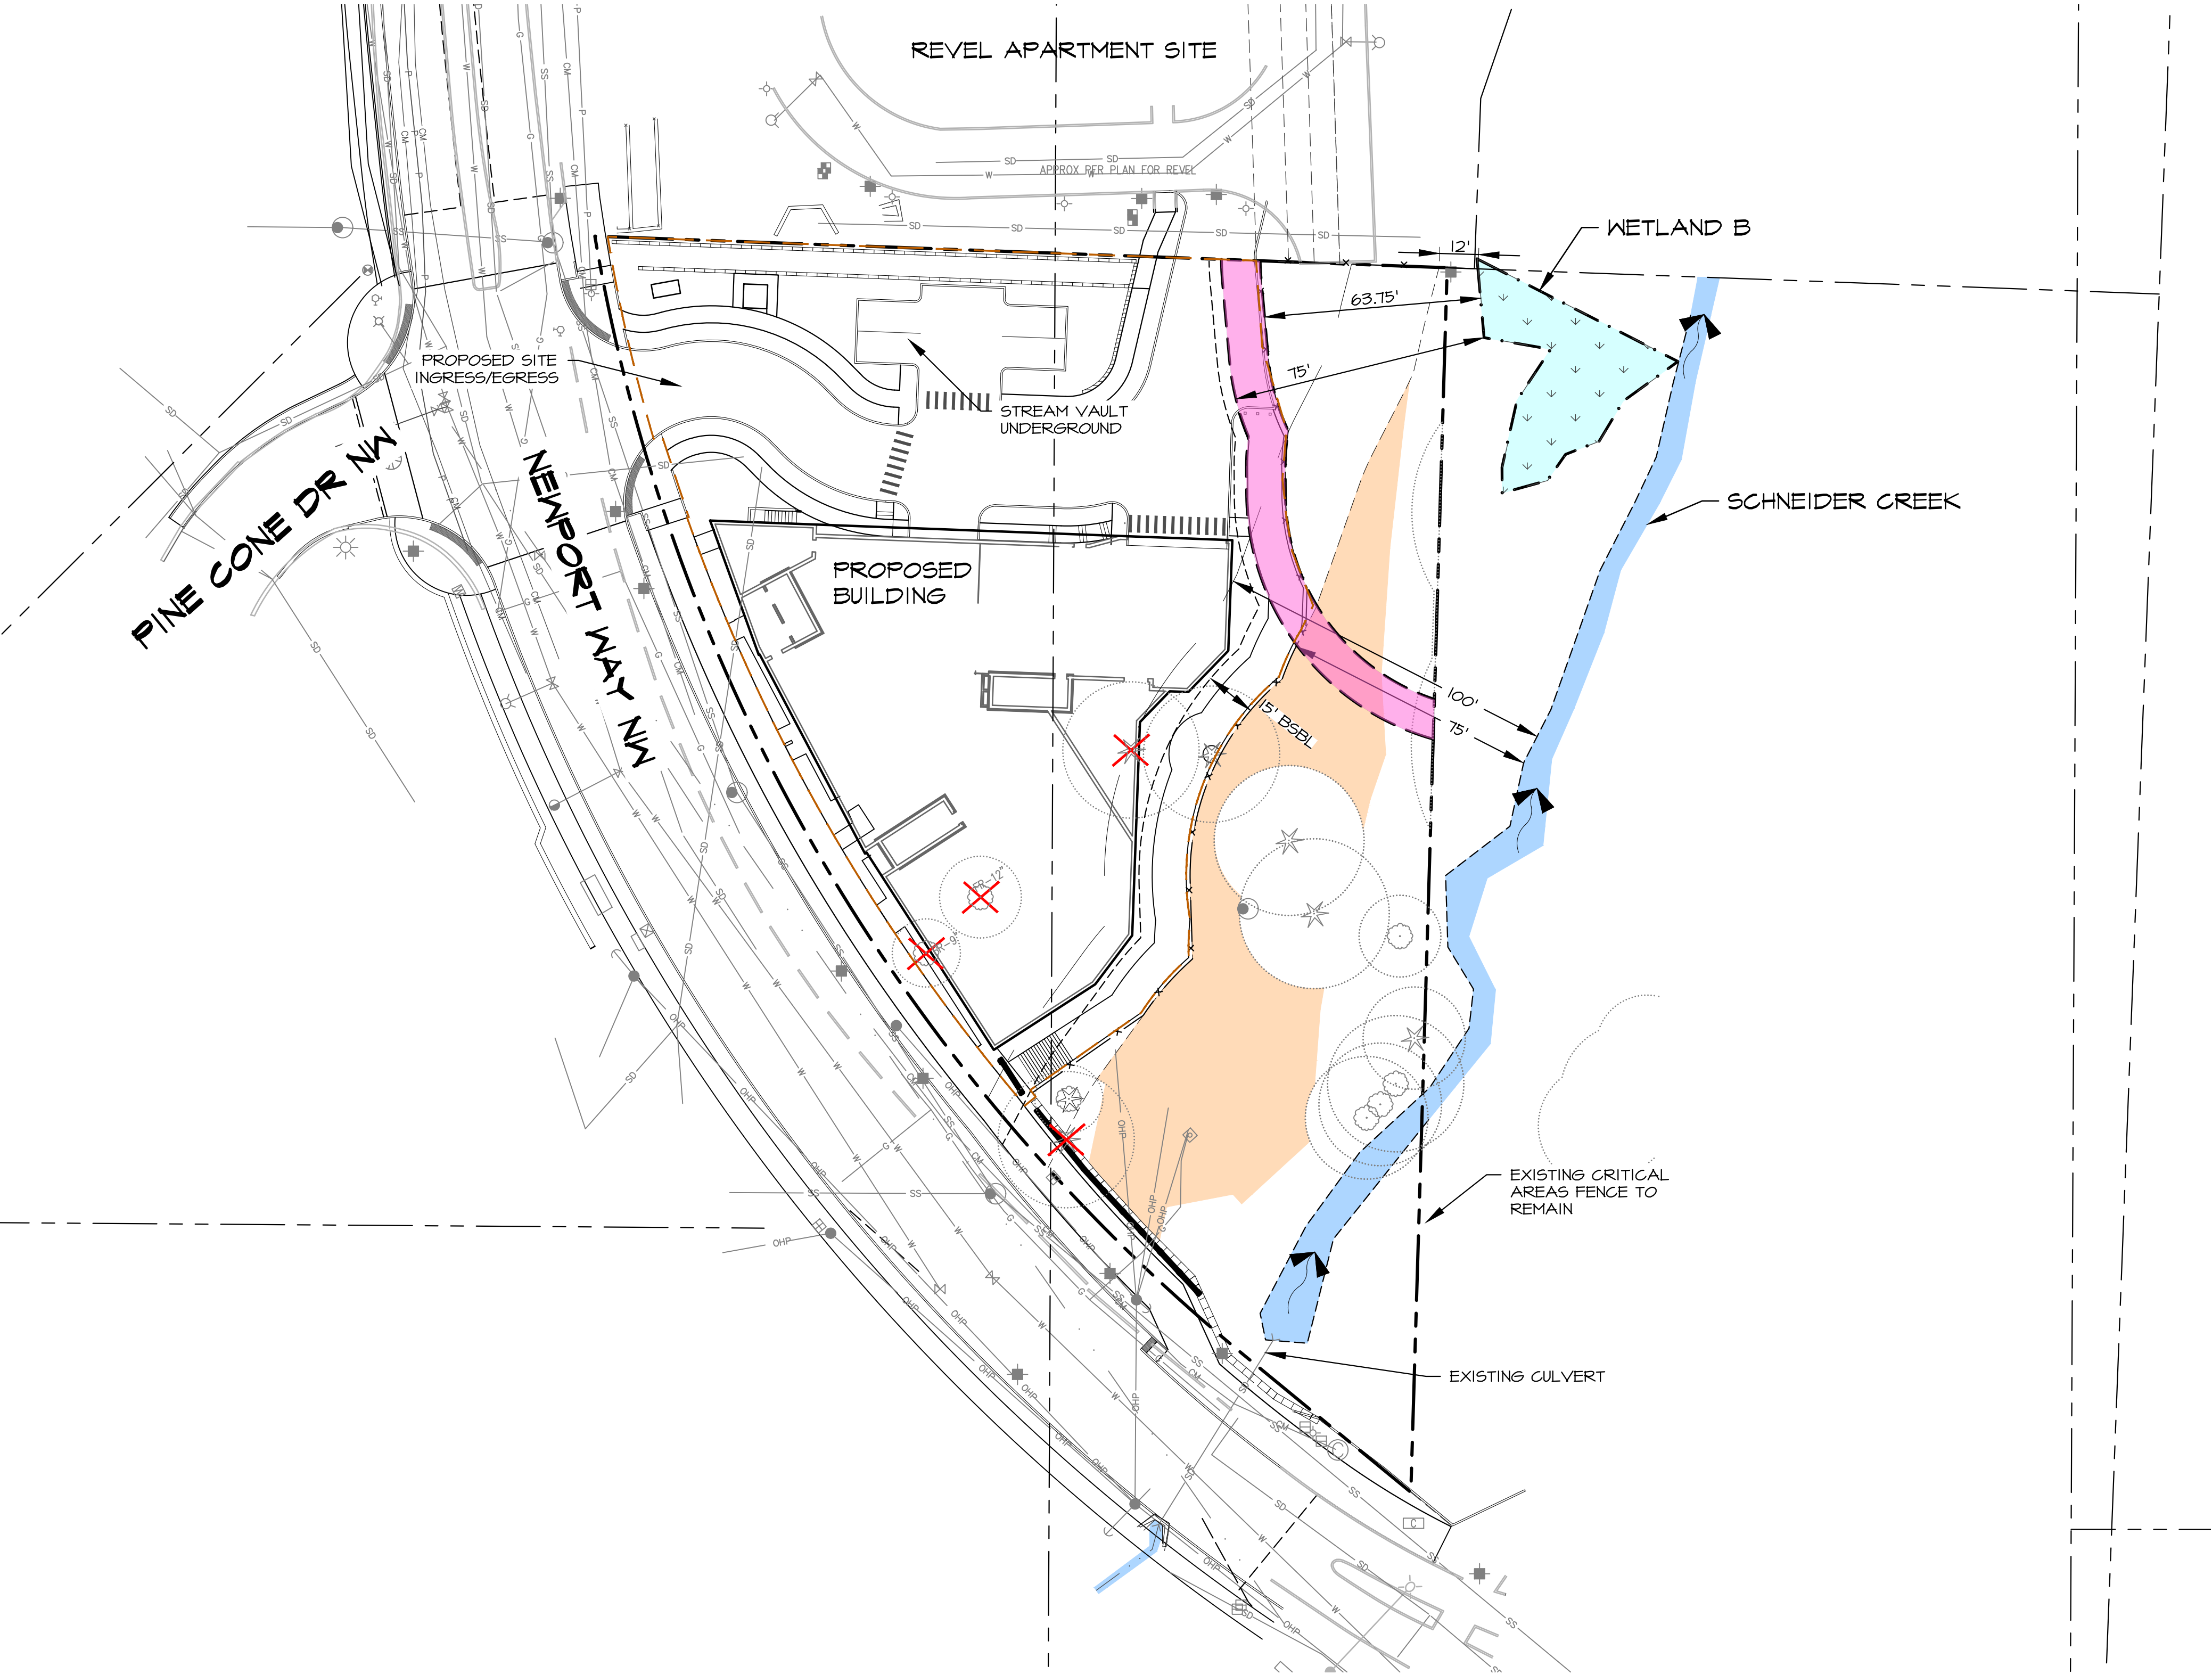
CRITICAL AREAS MITIGATION PLAN  
PROPOSED WETLAND IMPACTS OVERVIEW PLAN  
MILANO ISSAGUAH APARTMENTS PROJECT  
ISSAGUAH, WASHINGTON

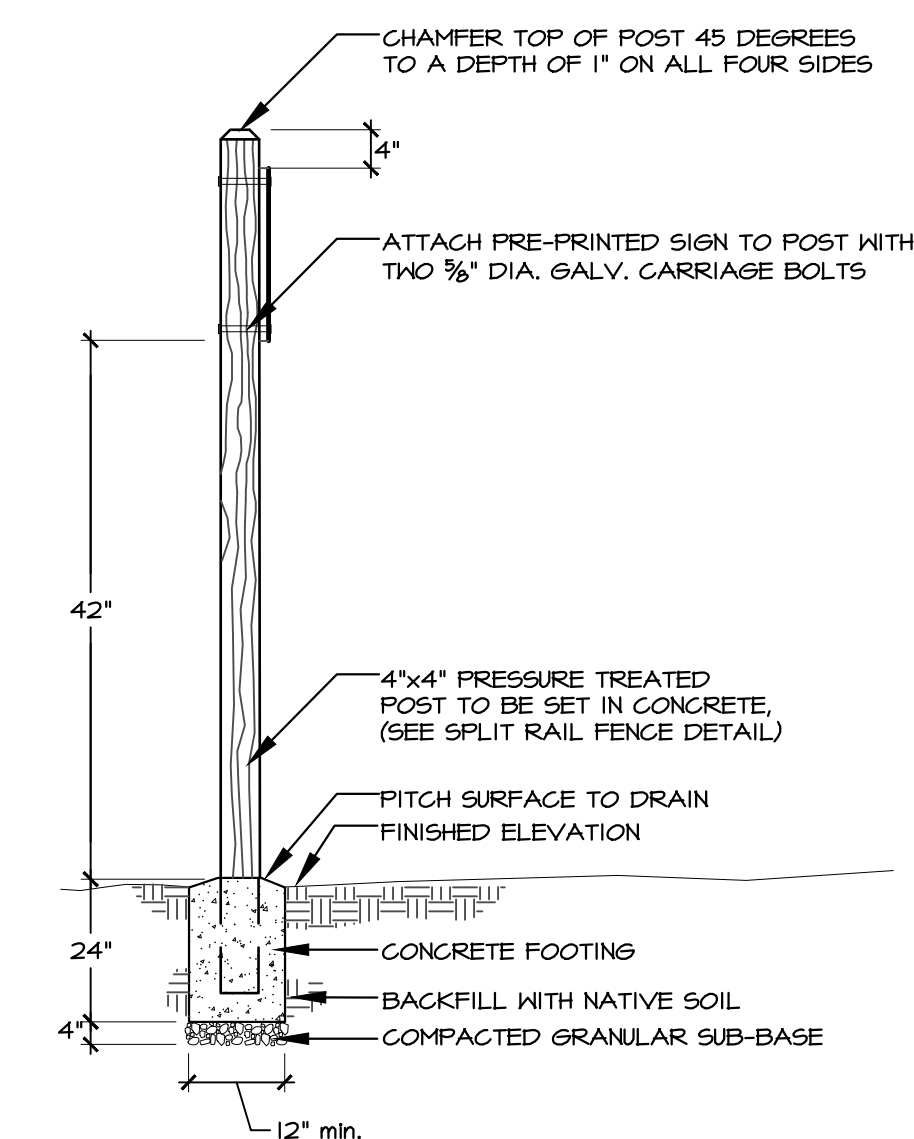
NGPA SIGN DETAIL TYP.  
N.T.S.

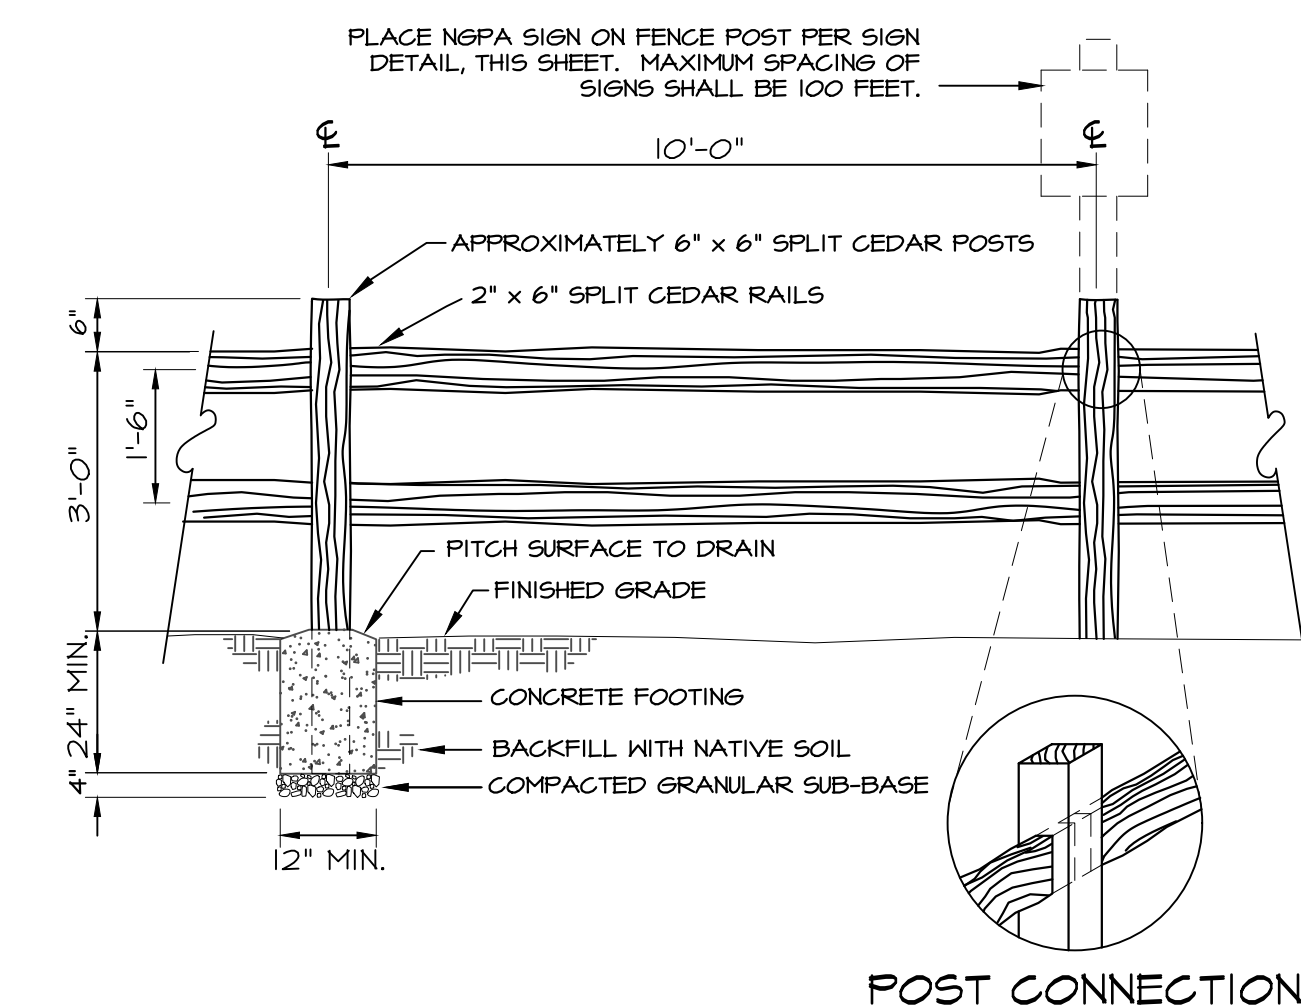
2 SPLIT 2-RAIL FENCE DETAIL  
N.T.S.
